Hazards of Uncoated Brass Flexible Gas Connectors in Older Homes

Certain older gas connectors may be dangerous.

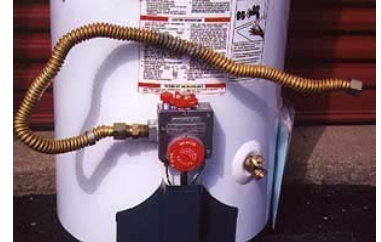
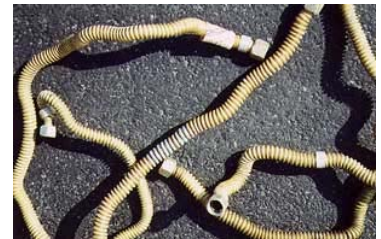
These brass gas-flex connectors were installed in older homes (pre 1976) These types of connectors are responsible for several failures. These connectors are used on water heaters, furnaces, clothes dryers and stoves. They are uncoated brass and will fracture if left in place.
Immediate Replacement Recommended.

Although not all uncoated connectors have this flaw, it is very difficult to tell which ones do. Therefore, any uncoated brass connector should be replaced immediately with a new stainless steel connector. Connectors can wear out from too much moving, bending or corrosion. Connectors should always be replaced whenever the appliance is replaced or moved from its location.

- Flex connector standard for a non-moveable gas appliance is ANSI Z21.24. It **MUST** be stainless steel.
- A flexible gas connector must bear a label that reads: U.L. approved; A.G.A. approved; or an ANSI standard.
- Install per the manufacturer's instructions.
